Dam Description

The Waimea Community Dam is a 53m high concrete face rock-fill embankment dam in the Lee Valley, 35km south-west of Nelson. Dam foundation treatment included construction of a cementitious grout curtain.

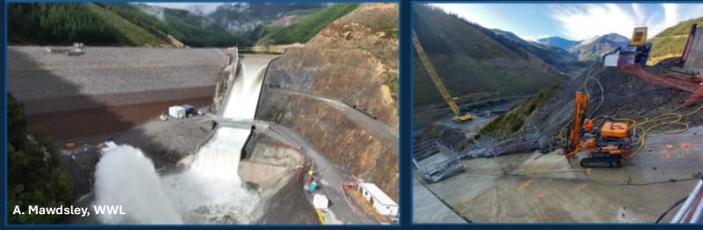
The geological environment generally comprises moderately strong, jointed, fissile interbedded argillite and sandstone, folded in varying orientations. Tectonism has generated multiple complex crush zones.

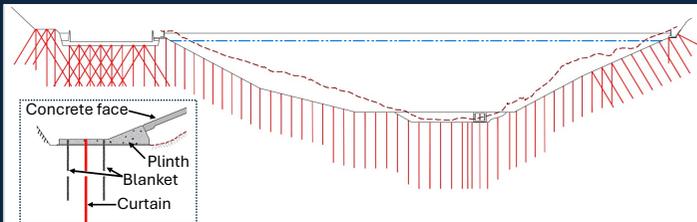
Two shallow (8m) blanket rows preceded a deeper (typ. 24m) central curtain. Grout hole depths and orientations were determined and refined through geological mapping and regular testing. A representative section of the grout curtain (primary holes only) is shown below, with the plinth shown inset.

Grouting comprised pressurised injection of cementitious grout through pre-drilled holes in the foundation through a plinth upstream of the face.

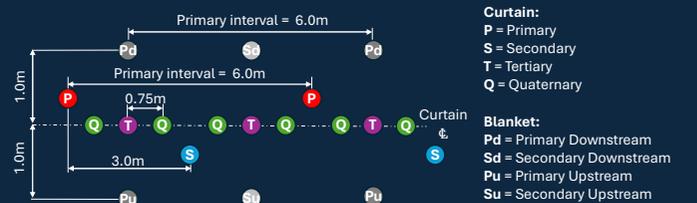
Split-space grouting on evenly spaced holes was generally applied, allowing efficient and well-informed construction. Schematically represented collar spacings are shown below. Primary, secondary, and tertiary holes were completed sequentially. Review of this data informed further grouting.

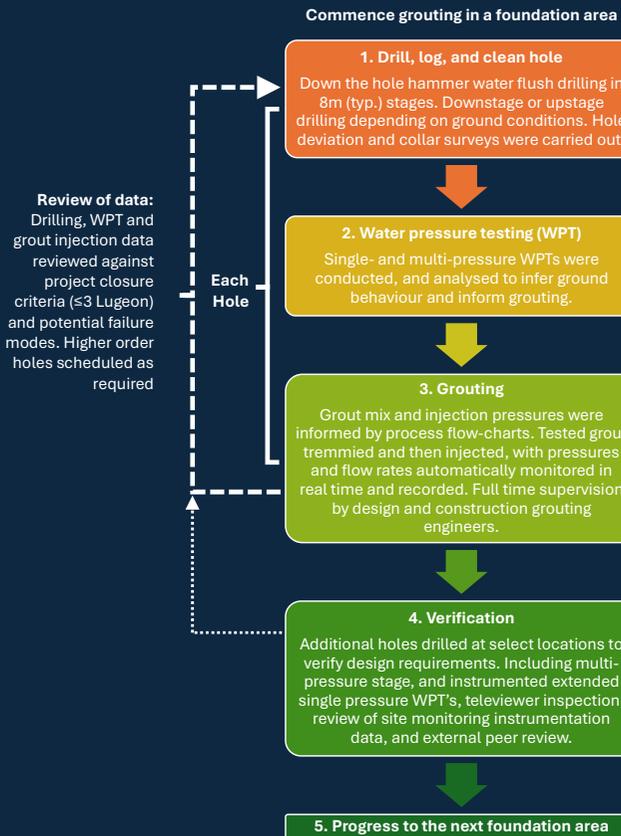
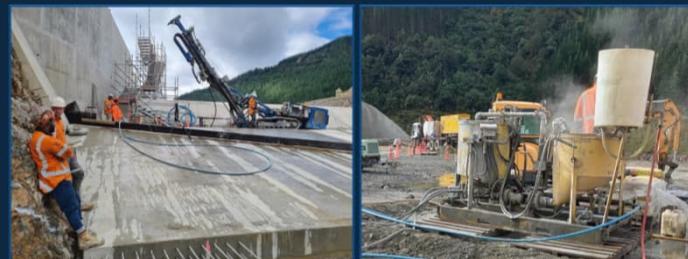
Construction was observational and iterative, following the process below.

Field trials determined safe but effective testing and injection pressures. Stable grout mixes were developed and tested on site to ensure suitable rheology for the ground conditions. High mobility, low pressure grouting was found to be suited to most parts of the site. Some parts of the site required the use of low mobility, low pressure grouting.
